FROM: California Fatality Assessment and Control Evaluation (CA/FACE) Program

SUBJECT: A Hispanic laborer operating an overhead crane died when he was crushed between two steel frames when the rigging failed

SUMMARY
California FACE Report #06CA001

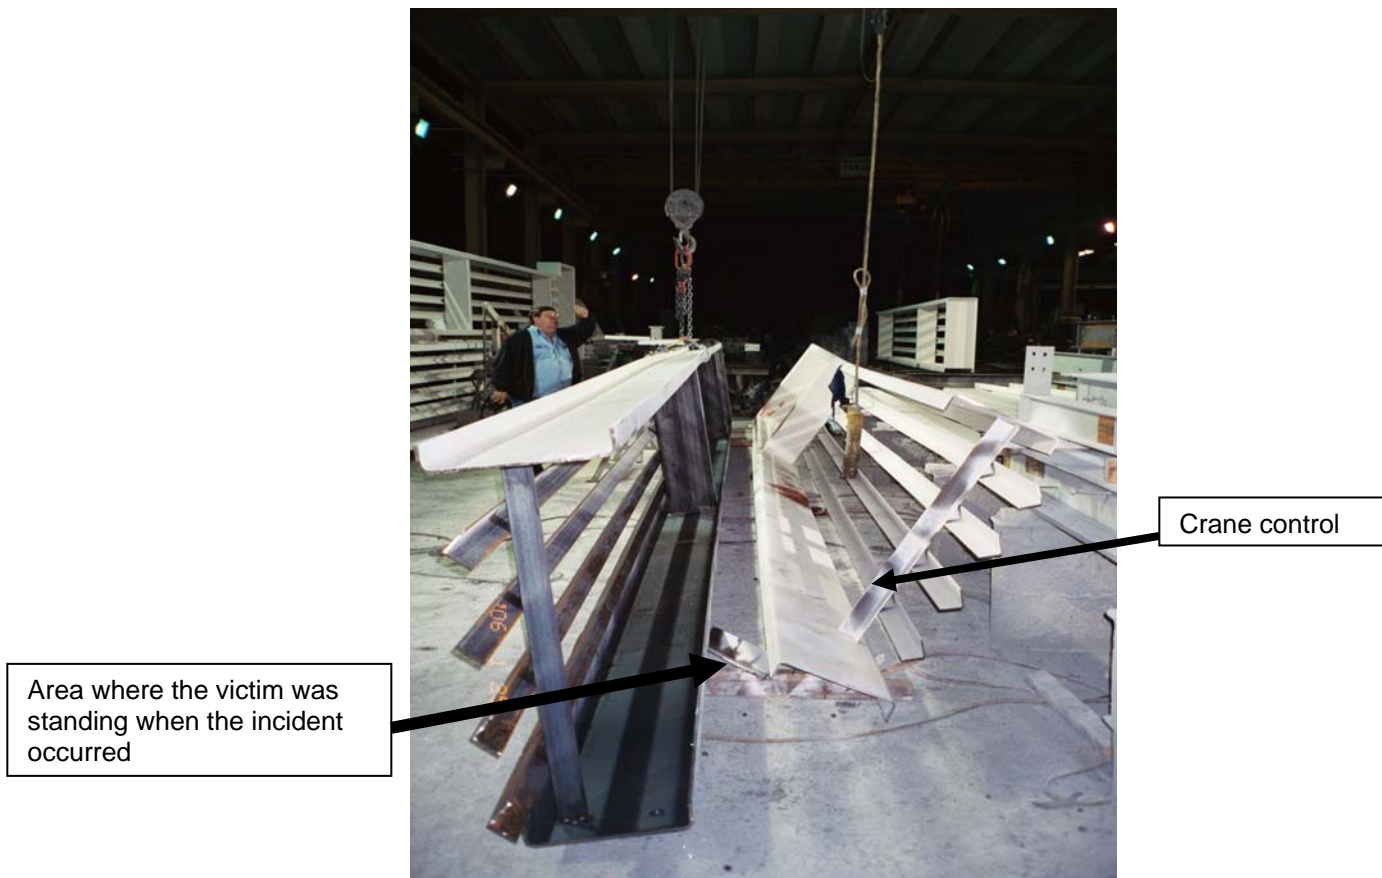
Discussion: In order to protect themselves and other employees, operators of overhead cranes must be constantly aware of their surroundings, and move their load in a controlled manner. In this particular case, the victim stood in an area where there was no exit should something go wrong. The victim should have avoided the areas directly under and close to the load. Employers can enhance worker compliance with safe work practices through programs of task-specific training, supervision, recognition, and progressive disciplinary measures.

Exhibit 6. A picture showing the area where the victim was standing and the crane control that the victim used to lift the steel frame.

Recommendation #1: Ensure employees do not place any part of their bodies into areas where they might become trapped when operating an overhead crane.
